Building Surveying Solutions
Chartered Building Surveyors

Building Inspection Report

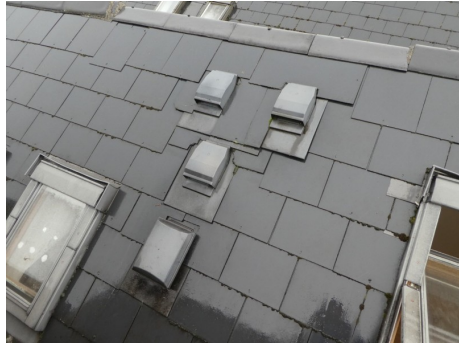
View of a small number of slipped and cracked artificial roof slates over the main roof

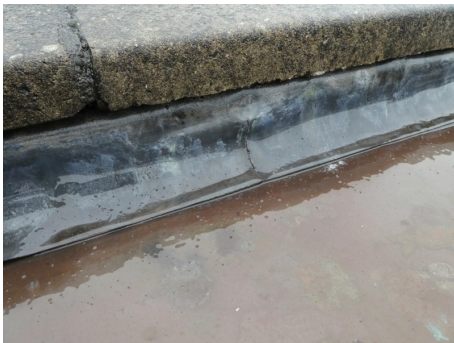
View of a cracked Lead flashing over the main roof parapet gutter; also illustrating contact between the Lead and copper where there is a bimetallic corrosion risk

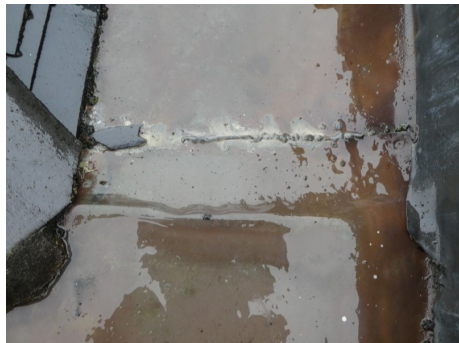
Typical view of a welded copper lining within the main roof parapet gutter which we suspect will have a limited life

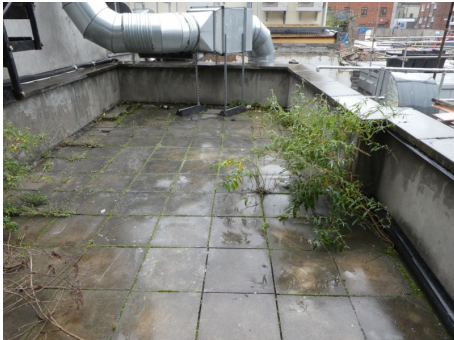
View of foliage growth noted on the rear elevation roof terrace

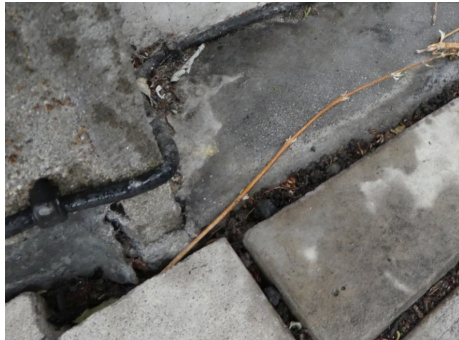
View of the poor flashing/weathering detail noted at the junction of the first floor rear elevation door threshold and roof terrace

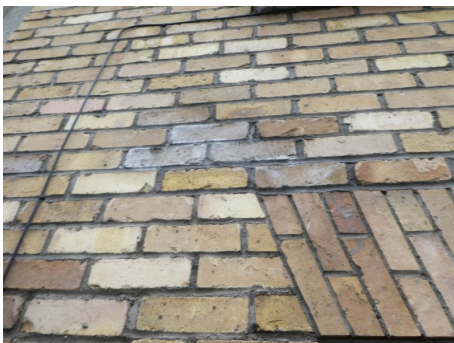
View of efflorescent salt staining noted to the front elevation brickwork

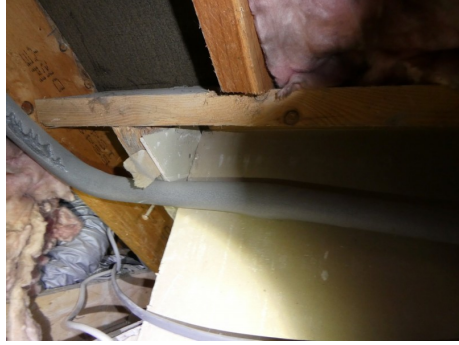
View of inadequate timber trimmers adjacent to a roof light within the roof space

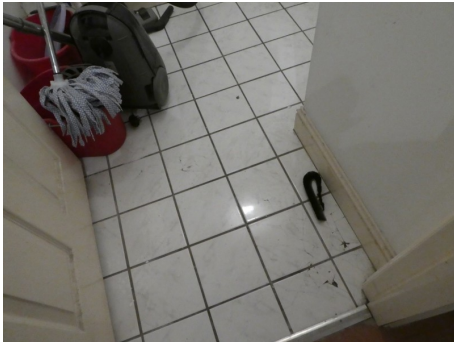
View of cracked floor tiles noted within a shower room

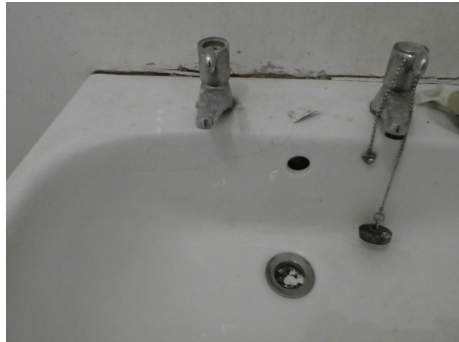
View of a cracked and defective wash hand basin
